# Determining Acceptable Levels of Weld Discoloration on Mechanically Polished and Electropolished Stainless Steel Surfaces

by Ken Kimbrel

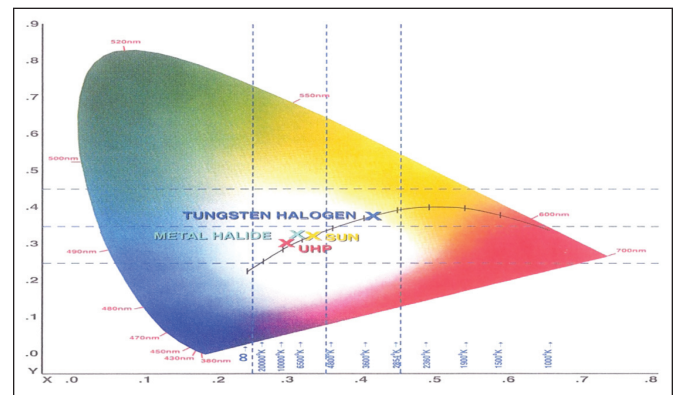
Figure 1. Spectral Output Chart Kelvin vs. Wave Length.

The spectral output of a lamp details the amount of electromagnetic radiation produced across a range of wavelengths, from ultra-violet (UV), through the visible spectrum, to infra-red (IR) - *Figure 1*. Radiation wavelengths are expressed in nanometers (nm), one nanometer being 10<sup>-9</sup> meters.

The visible spectrum is between approximately 390 and 770 nm, with ultra-violet being below and infra-red being above this range. In order to give true color images, the light source should have a relatively even output across the visible spectrum. Ideally, the amount of IR radiation produced should be minimized, as IR radiation is converted to heat, which may then require a dissipation system. The spectral outputs of the three most frequently used lamp types are shown in *Figure 1* and compared with that of the sun.

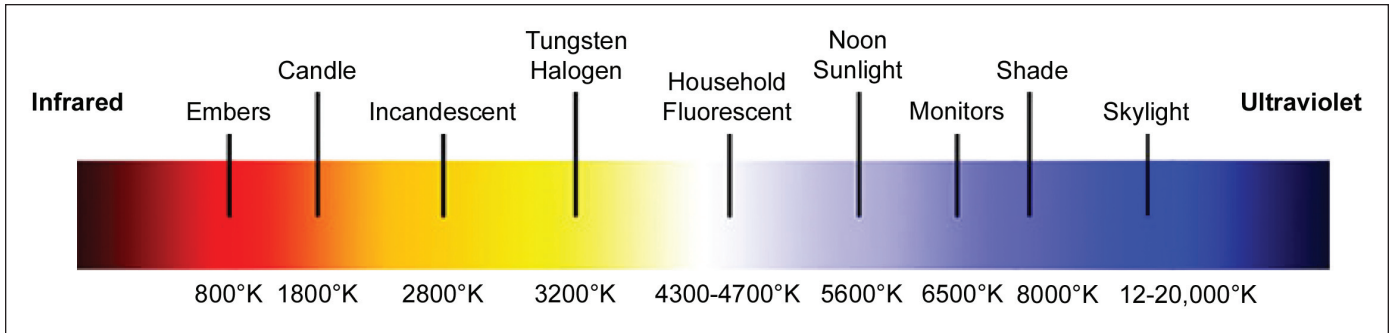
Figure 2. Color temperature imaging.

The color temperature of a lamp is an indication of its radiance and is measured in degrees absolute (°K in SI units) - *Figure 2*. Typically, tungsten-halogen lamps have a color temperature of 3,200°K, while metal-halide and UHP arc lamps are around 5,600°K. The color temperature of the sun is 5,900°K. With tungsten-halogen lamps, the color temperature can be reduced by decreasing the voltage across the lamp filament. Some light sources use this method to adjust the “intensity” of the light output. Unfortunately, this “rheostat” type control increases the “yellowing” of the resultant illumination.

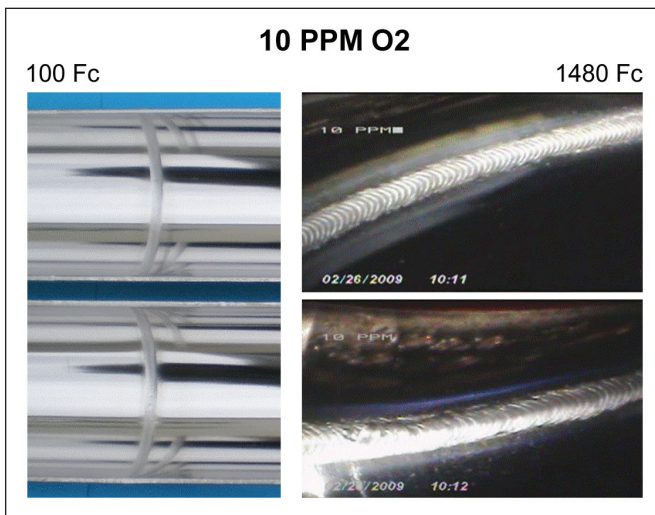
Figure 3. The photo at left illustrates the color on the weld and in the HAZ of a weld made with 10 ppm O<sub>2</sub>. The photos far left show the weld discoloration using the naked eye while the photos nearest show the same weld as viewed with a boroscope at 1480 Fc power.

To further illustrate the effect the light source can have on color, *Figures 3, 4, and 5* show the impact of viewing color on welds at different oxygen levels. Each photo in the following three examples show autogenous weld on the outside diameter of a piece of 1-1/2" 316L stainless steel tube split in half. Each

is then examined using the naked eye vs. 1480 Foot candle (Fc) power under a boroscope utilizing a 50W metal-halide lamp.

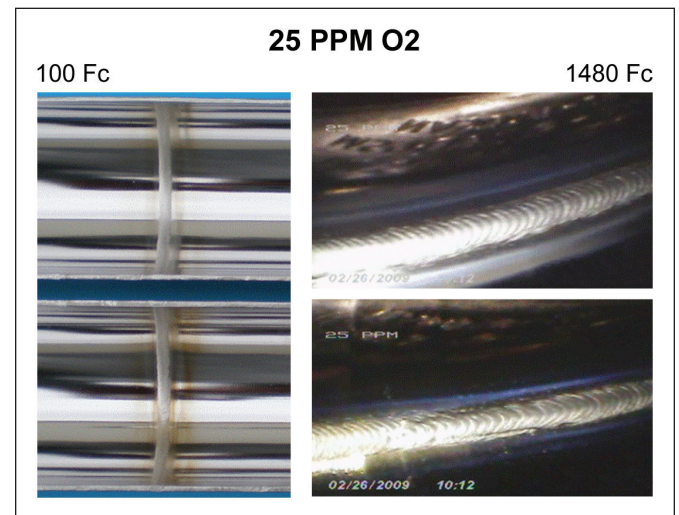
Figure 4. The photo at left illustrates the color on the weld and in the HAZ of a weld made with 25 ppm O<sub>2</sub>. The photos far left show the weld discoloration using the naked eye while the photos nearest show the same weld as viewed with a boroscope at 1480 Fc power.

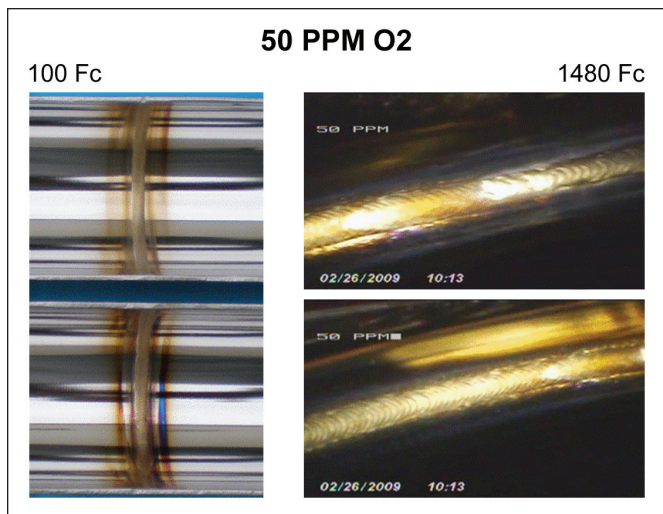
Figure 5. The photo at left illustrates the color on the weld and in the HAZ of a weld made with 50 ppm O<sub>2</sub>. The photos far left show the weld discoloration using the naked eye while the photos nearest show the same weld as viewed with a boroscope at 1480 Fc power.

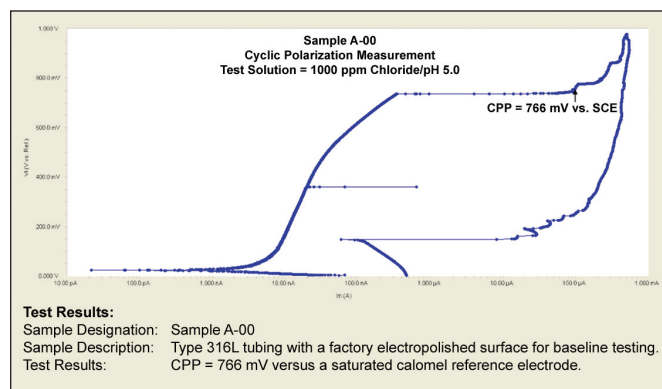
Figure 9. Cyclic polarization measurements.

Thirteen sample coupons with representative color in the HAZ of the welds were provided as indicated in Table A. A modified ASTM G 61 cyclic polarization test to determine the critical pitting potential (CPP) of type 316L stainless steel was used to evaluate each sample after a specific process as listed below. The test solution consisted of 1000 ppm chloride mixed from NaCl with an adjusted pH of 5.0. The CPP is defined as the potential where the current density reaches a level 100 microamps/cm<sup>2</sup>. The photographs seen in Figures 6, 7, and 8 are representative samples of those shown in Table A and tested with the results in Figure 9.

The Figure 9 graph is a sample shown for reference of the Cyclic Polarization Measurements as charted in Table B. Table B is a summary showing the resulting value of the Critical Pitting Potential as determined by the Cyclic Polarization tests for the 13 control samples. The higher the pitting potential number, the better the corrosion resistance.

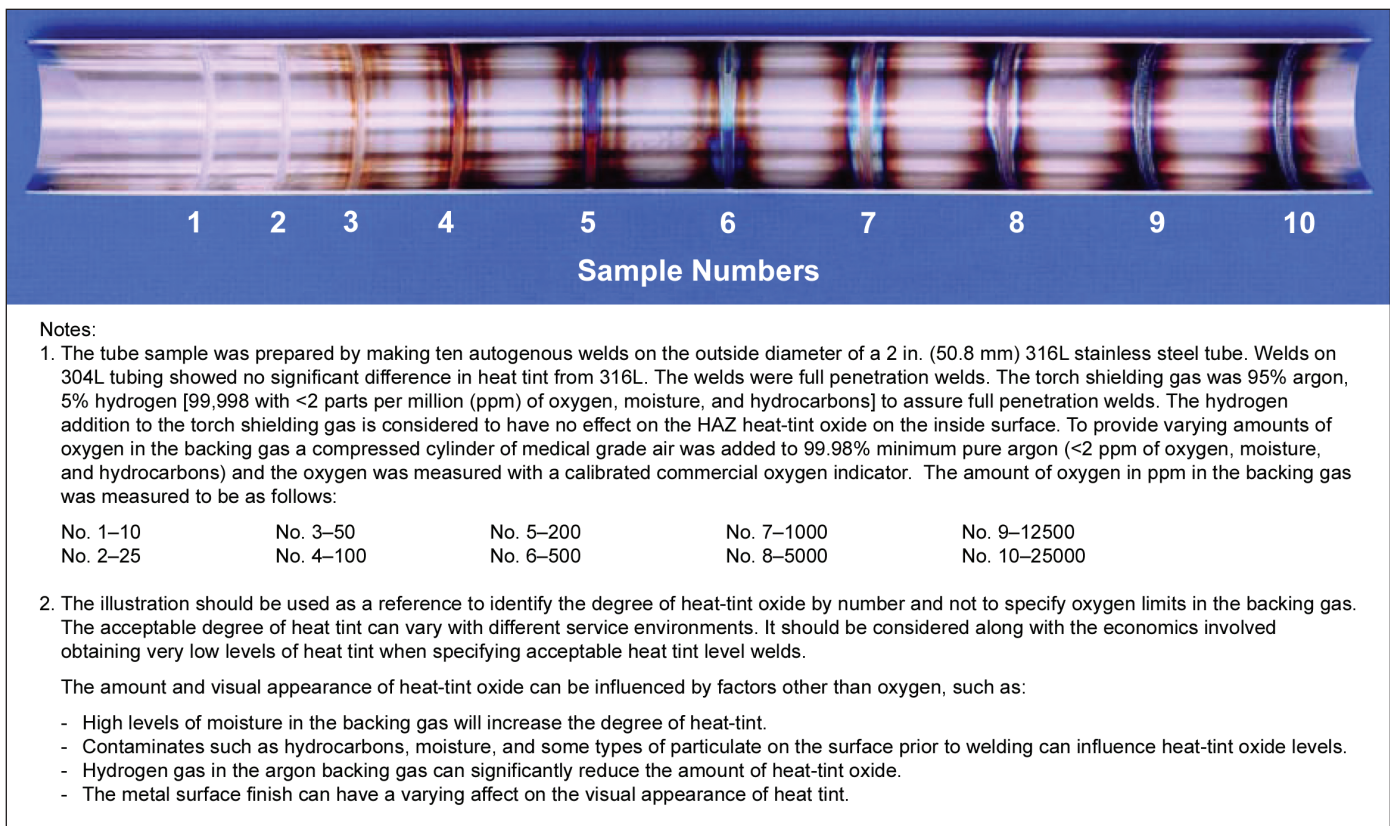
Figure 10. AWS D18.2 weld discoloration chart.

For comparison of color being viewed through a boroscope in a field application and the AWS D18.2 chart shown in Figure 10 being used to establish acceptable color levels, it is important to point out the chart is being viewed on a cut piece of tubing with an unknown light source being emitted on the surface using the naked eye. In most field applications, the welds are being viewed utilizing a boroscope with an unspecified light source or viewing monitor which can emit variations on the outcome as described in the “Inspection Equipment” section above.

levels of color present, that the electropolished surfaces are more corrosion resistance than those receiving only a mechanical polish. Therefore, color levels on electropolished surfaces may vary from those shown in the industry accepted AWS-D18.2 chart. Figure 10 (AWS D18.2) shows the different colors associated with O<sub>2</sub> levels on mechanically polished tubing in comparison with Figure 11 (Cotter Bros. Chart #143)

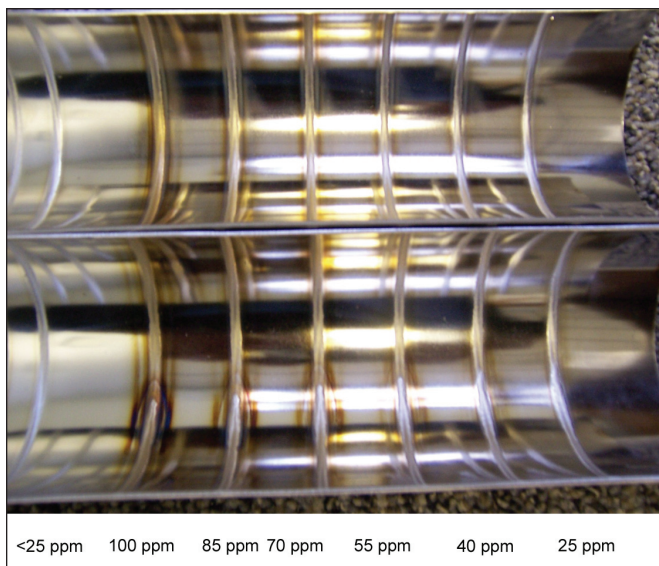
Figure 11. Cotter Bros. chart #143 weld discoloration chart for electropolished material.

illustrating color levels typically found on electropolished tubing with similar O<sub>2</sub> levels.

A color chart recognizing the effects of color for electropolished material should be developed and adopted for the pharmaceutical industry showing accurate acceptable levels of color - *Figure 11*. Inspectors and those responsible for evaluating color on welds should undergo color visual acuity tests yearly and should provide documentation of testing as deemed necessary by the owner or equipment supplier prior to the inspection process.
